CONTROL OF WIND EROSION

December, 1971

RESEARCH REPORT

CA-HWY-MR 642118(1)72-02

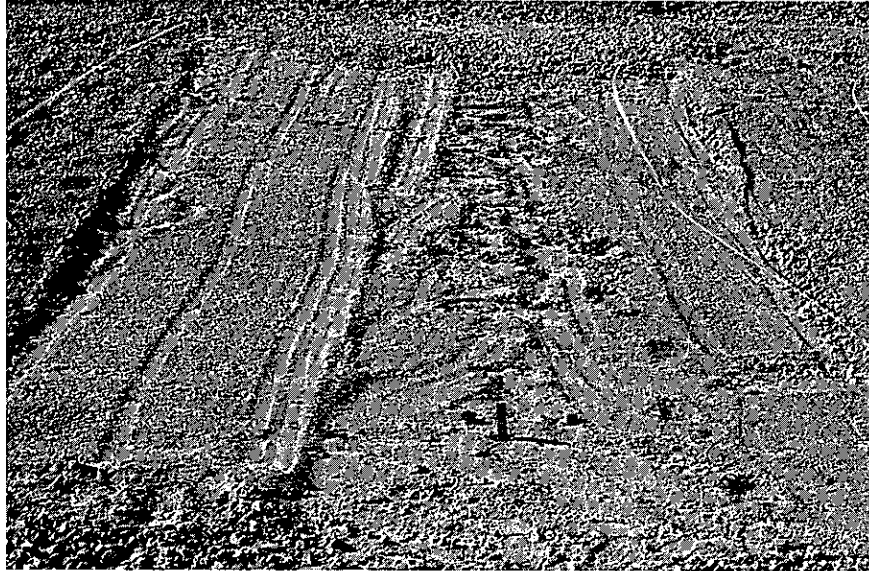
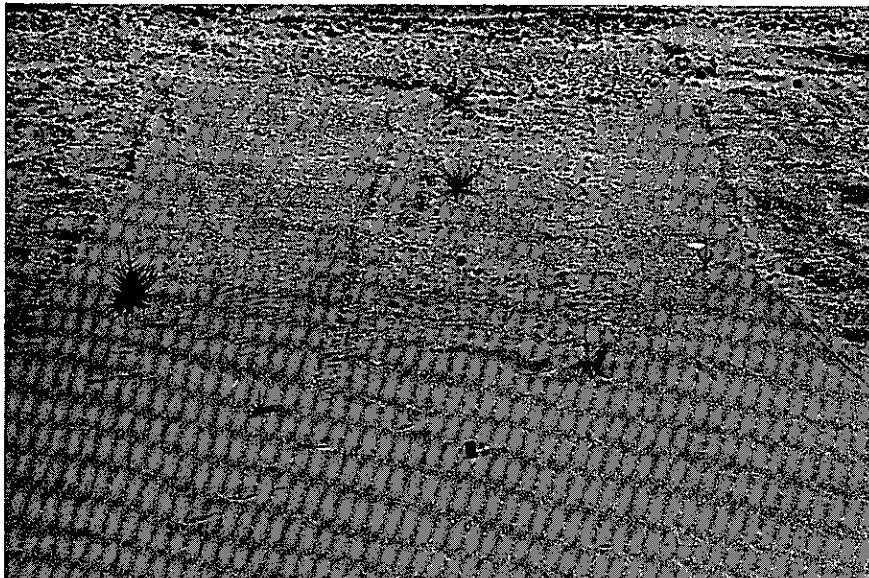
Plate 12 - Control Plot

The control plot, shown in Plate 12, was left untreated as a basis for comparison to the performance of the materials being tested. The surface of this control plot was sprinkled with water and a very weak crust did form. The blowing sand quickly destroyed this crust and most of the fine material on the test plot was subsequently blown away. As can be seen in Plate 12, a motorcycle was driven up the left side of this test plot.

Note motorcycle track

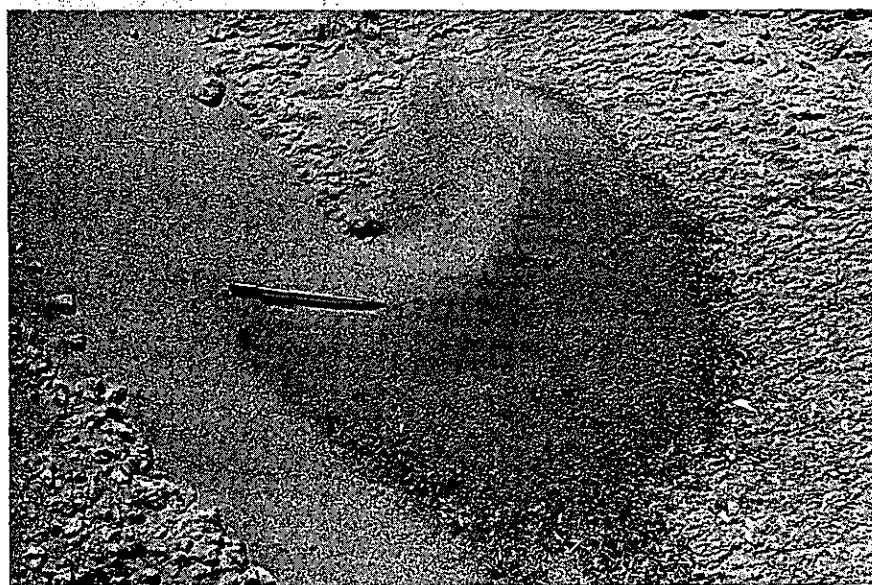
Insects have excavated burrows (Plate 14) in nine of the test plots. These burrows appear to be independent of the treatment materials and have not affected the performance so they were not considered in making the evaluations.

Plate 14 - Damage to test plot by burrowing insect.

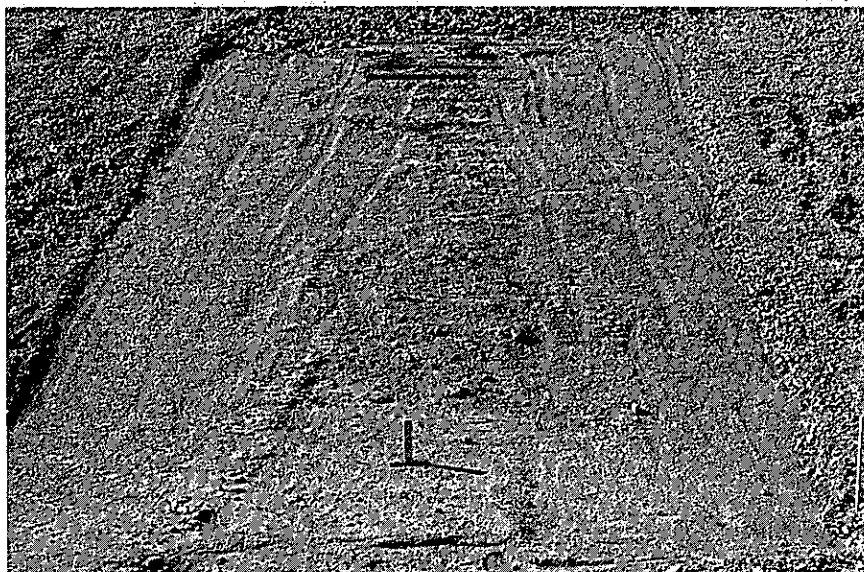
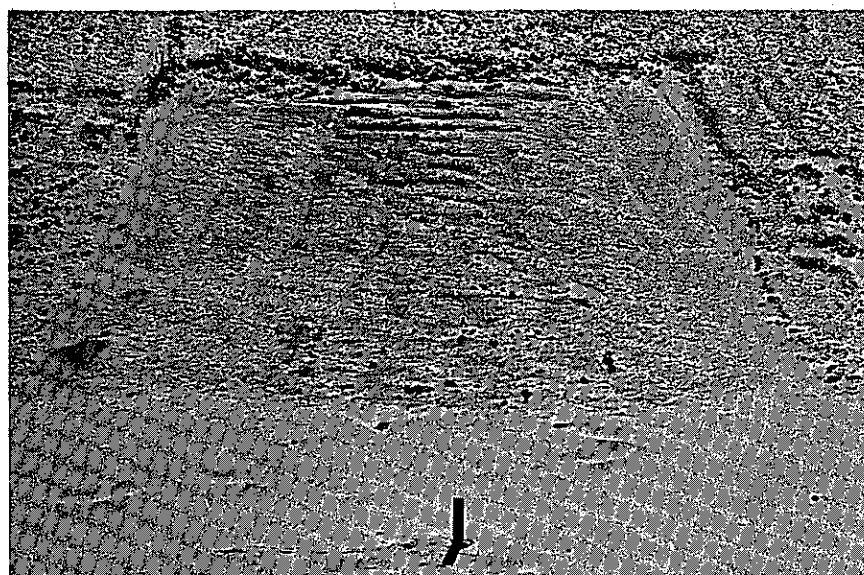
Plate 15 - Aerospray 52

The performance of Aerospray 52 was judged marginal because the blowing sand had severely scoured the surface of the test plots and had locally cut through the crust. It should be noted that one plant did grow in one of the Aerospray test plots. This agrees with previous observations and suggests that Aerospray 52 may not be as severe in inhibiting germination as most other products tested in this study.

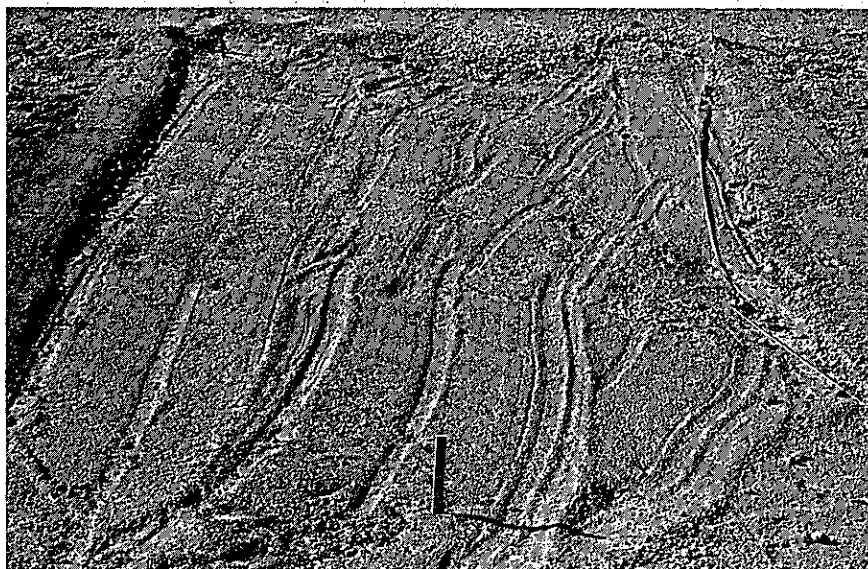
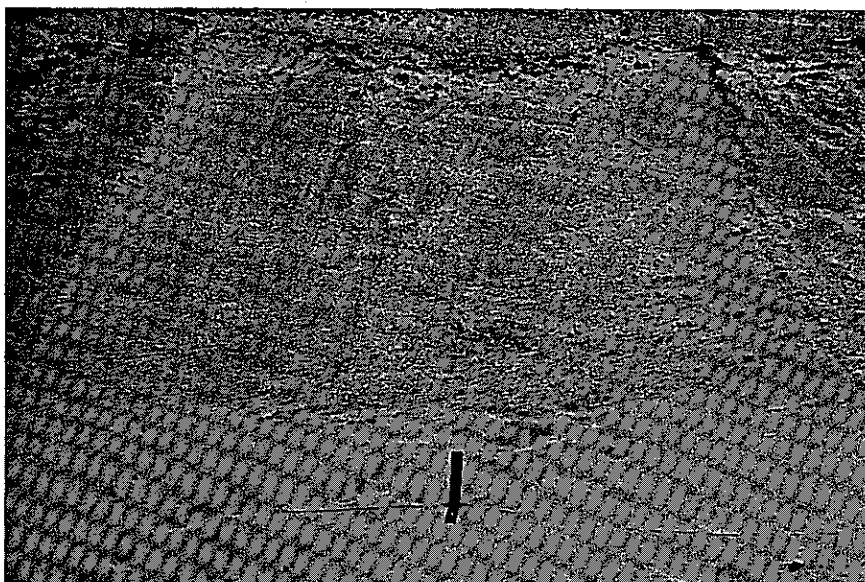
Plate 17 - Aquatain

The performance of Aquatain was judged unsatisfactory because blowing sand had completely abraded the crust away and the wind subsequently stripped most fine material from the test plot.

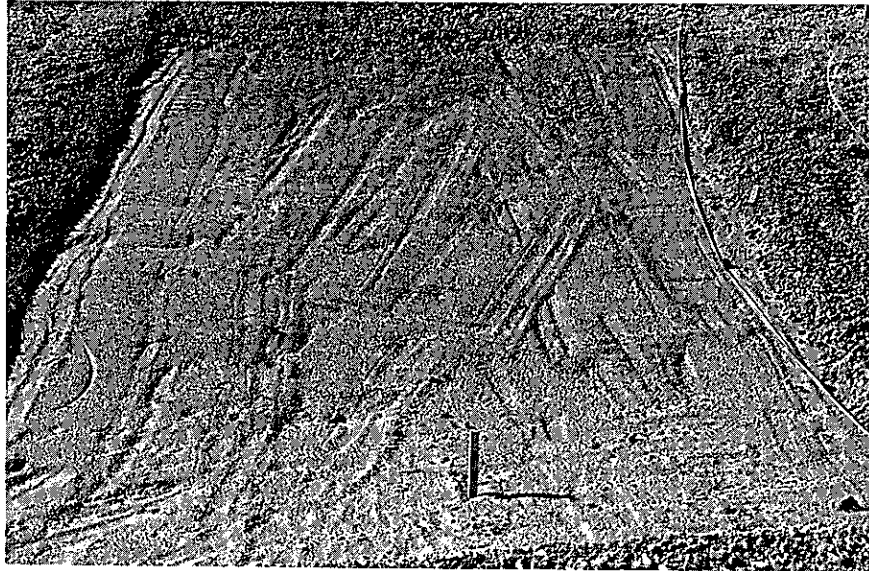
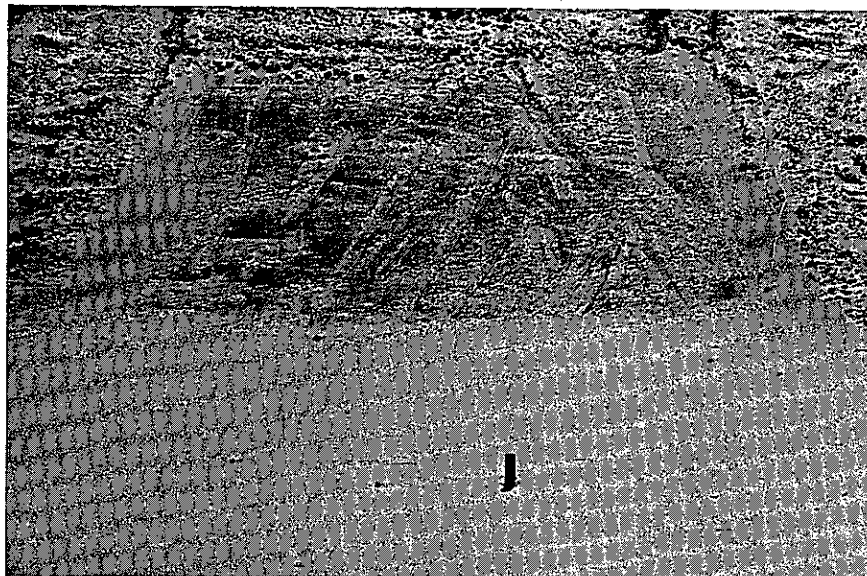
Plate 19 - Coherex

The performance of Coherex was judged marginal because while the flexible surface did not strip away it was penetrated by the blowing sand largely because of limited penetration by the Coherex emulsion.

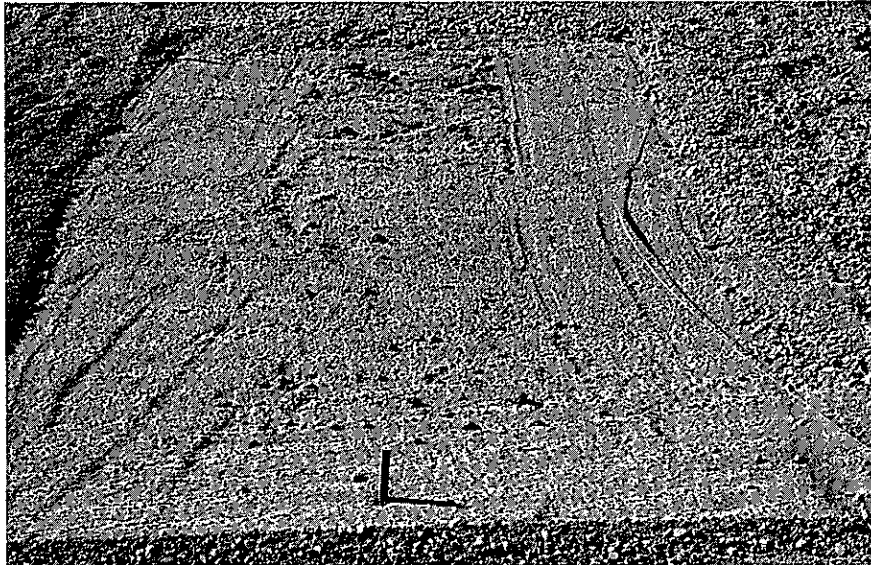
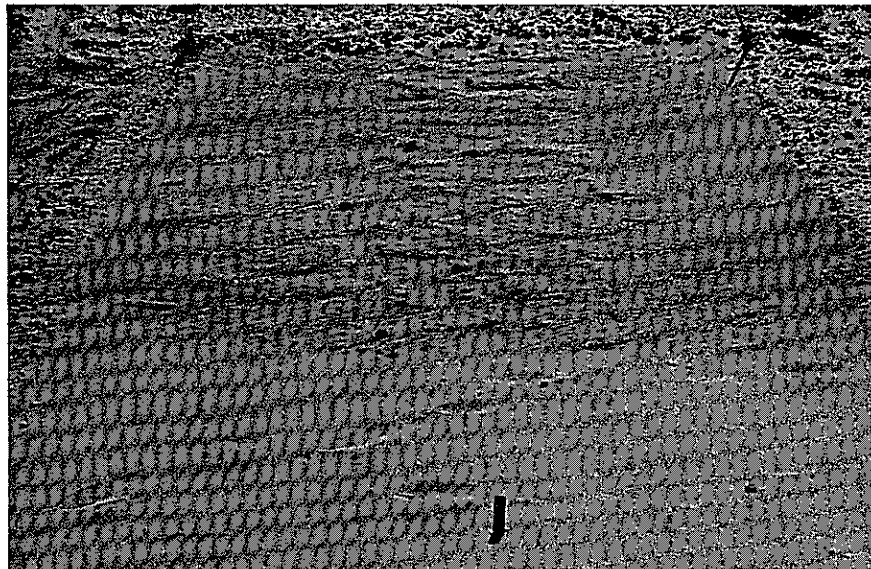
Plate 21 - Conwed Fiber

The performance of Conwed Fiber was judged satisfactory because it showed absolutely no sign of distress. The reason for this performance was the development of a thin sand blanket which formed over the fiber and which neither blew away nor became thicker.

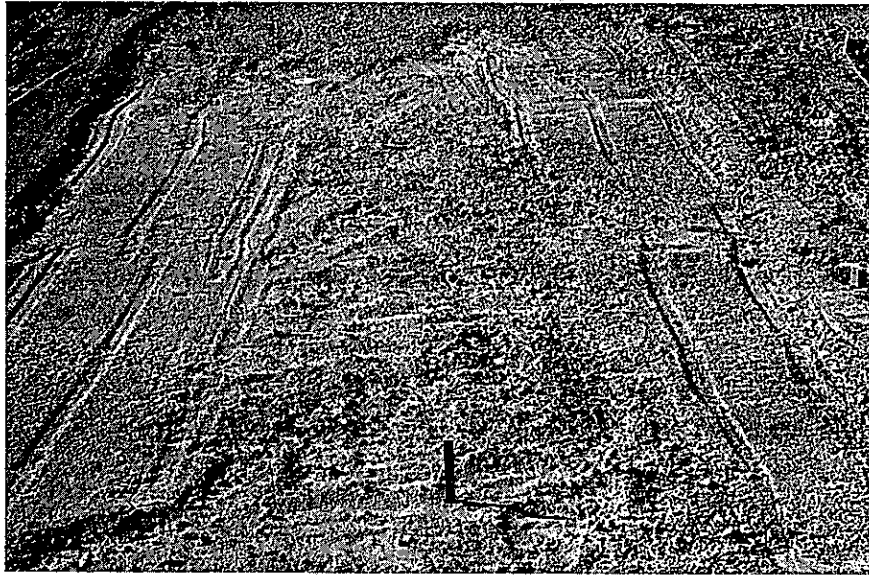
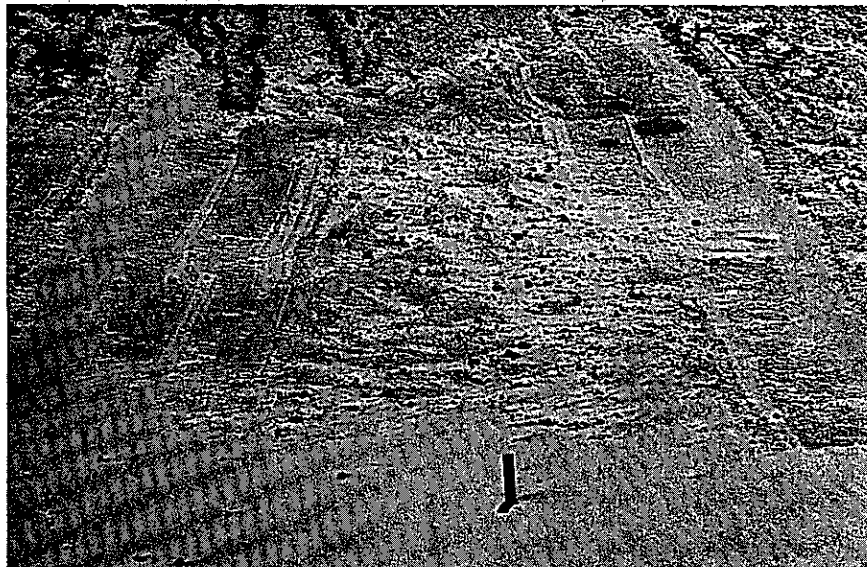
Plate 22 - Curasol AE

Curasol AE performed satisfactorily because although the surface was scoured by blowing sand it was not penetrated.

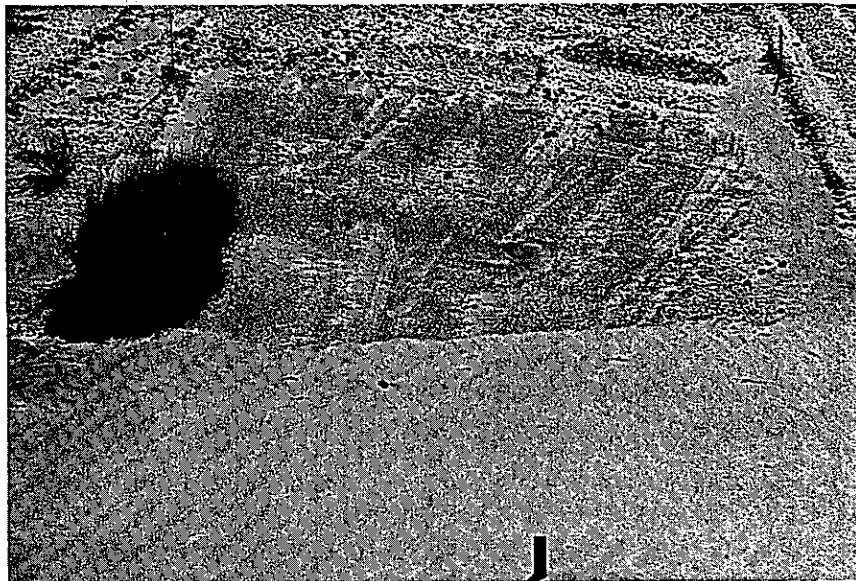
Plate 24 - Curasol AH

The performance of Curasol AH was judged satisfactory because although scoured by blowing sand, the surface was not penetrated. One plant grew on the Curasol AH test plot at the southeast edge. This particular plant appears to have started in an accumulation of blow sand and the roots then penetrated the Curasol surface.

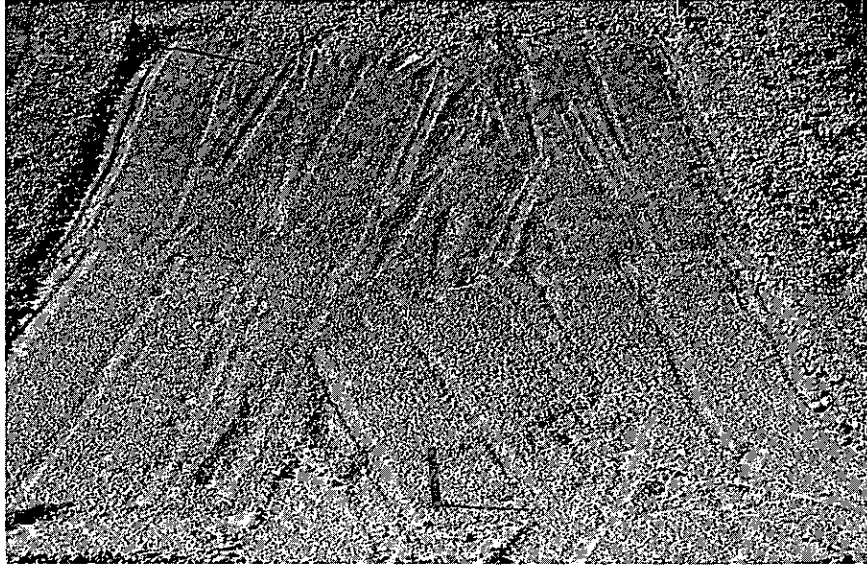
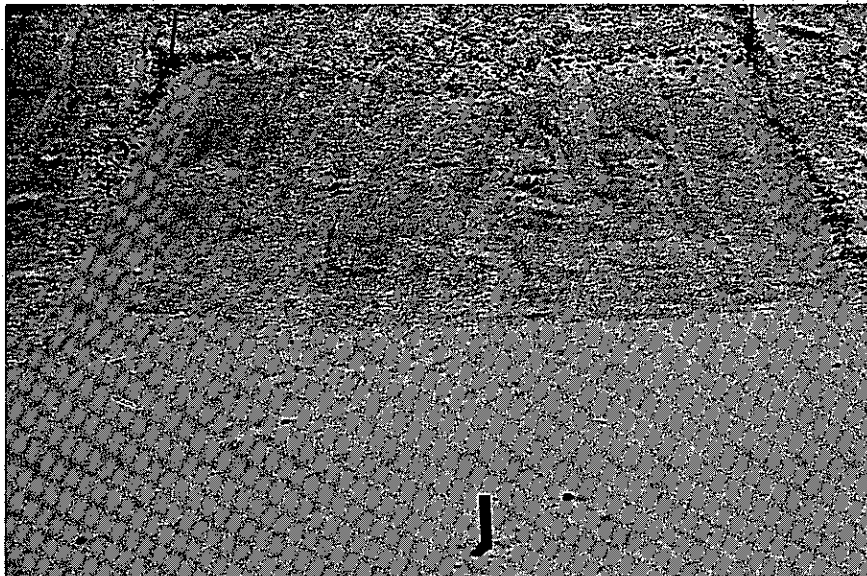
Plate 25 - Ecology Control

The performance of Ecology Control was judged unsatisfactory because blowing sand had severely scoured the surface and had penetrated the surface over most of the area of both test plots.

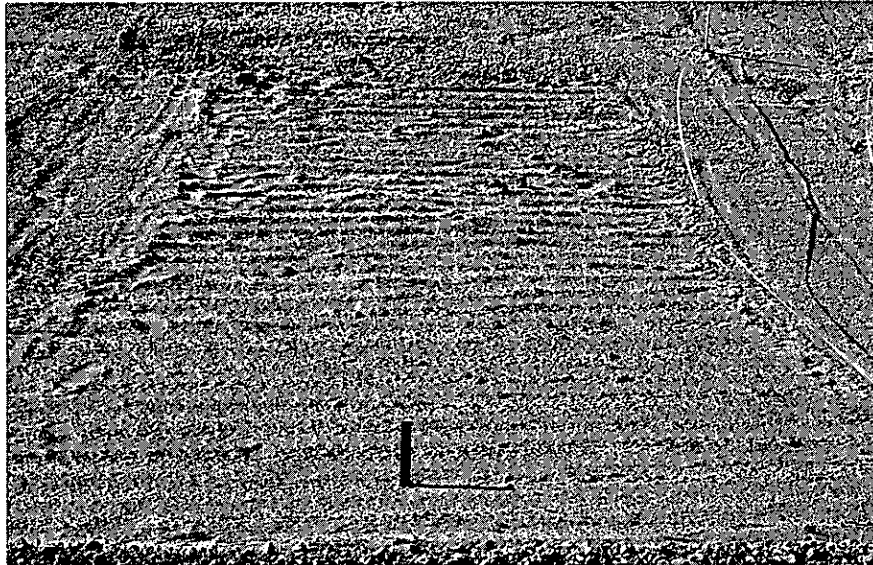
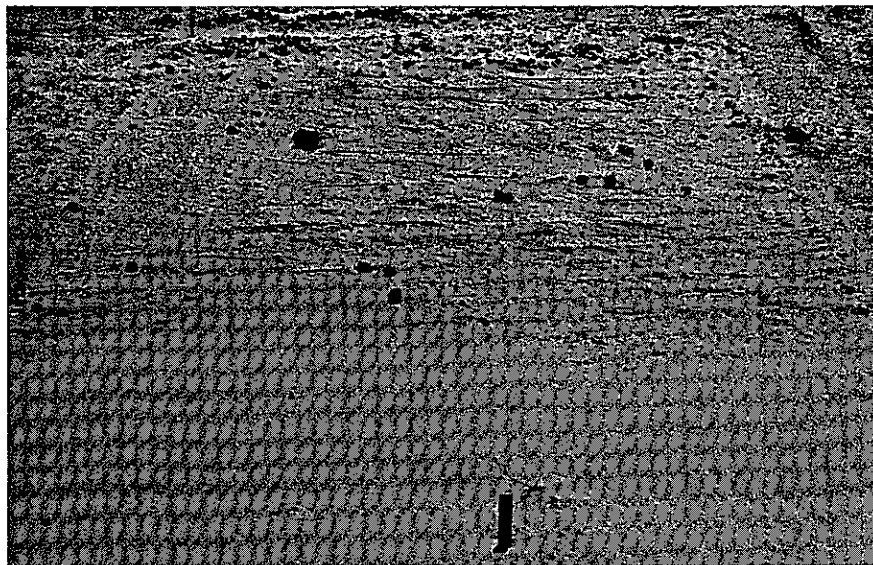
Plate 27 - Erode-X

The performance of Erode-X was judged marginal because blowing sand had severely scoured the surface and had locally penetrated the surface.

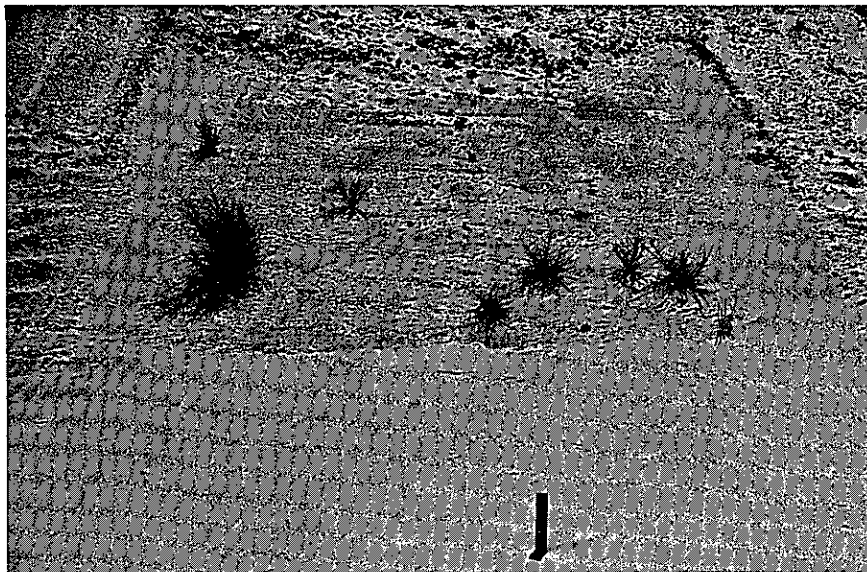
Plate 29 - Glenkote

The performance of Glenkote was judged marginal because blowing sand had severely scoured the surface and locally had penetrated it.

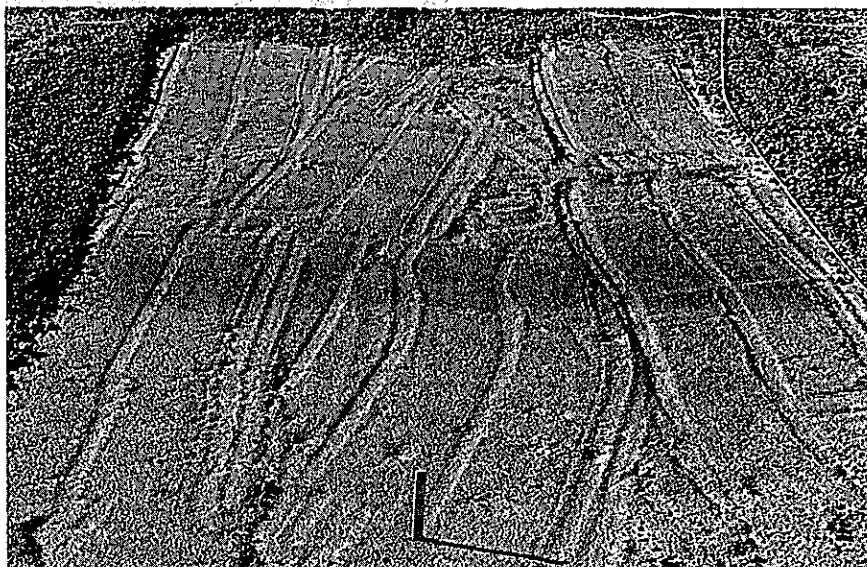
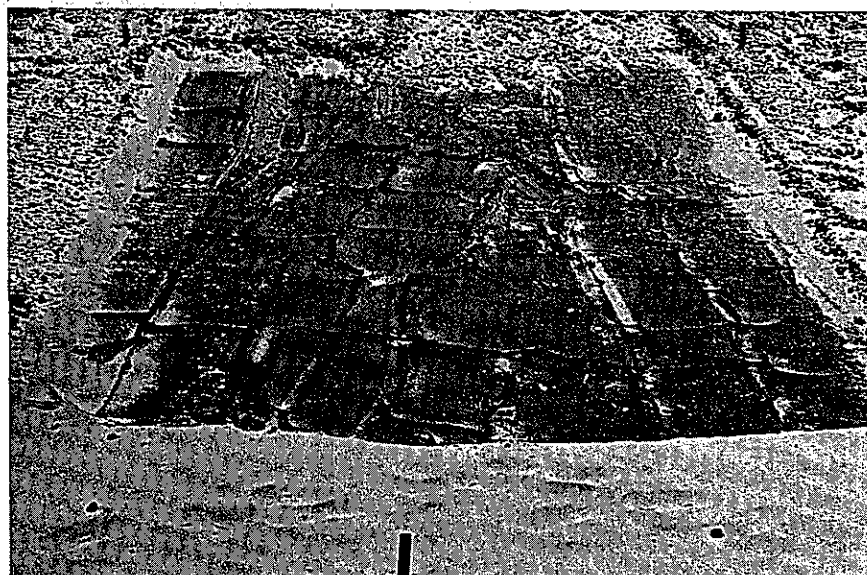
Plate 30 - Orzan

The performance of Orzan was judged satisfactory because the surface was not damaged at all. The color and shrinkage cracks are definite disadvantages that should not be forgotten.

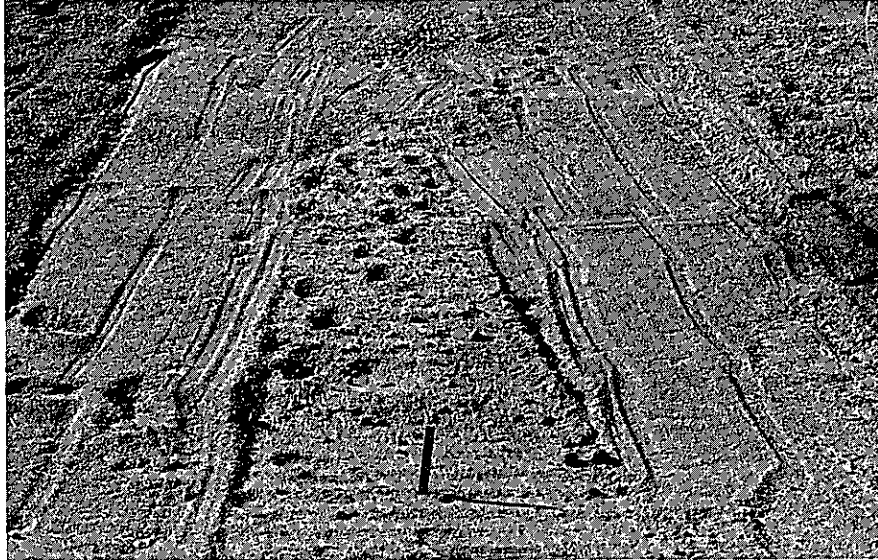
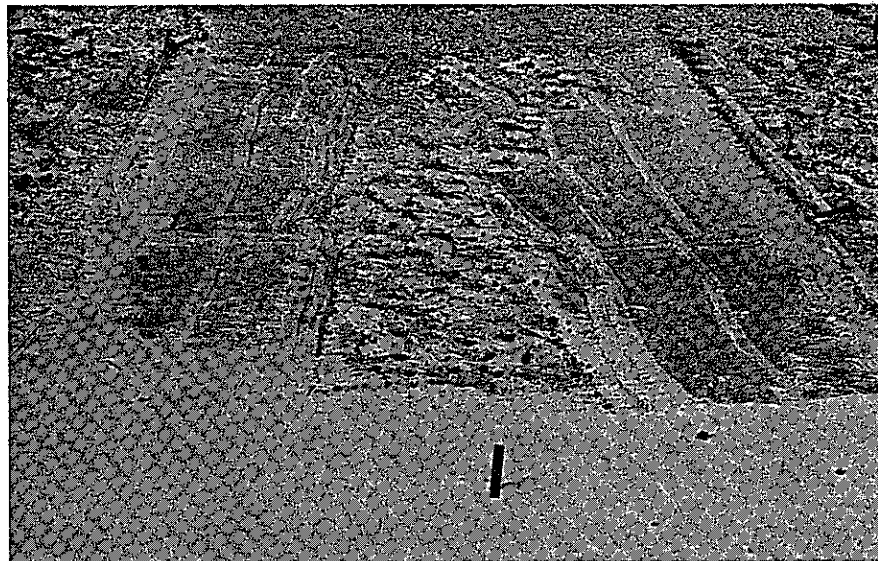
Plate 33 - Soilmaster

The performance of Soilmaster was judged marginal because blowing sand had severely scoured the surface and locally had penetrated it.

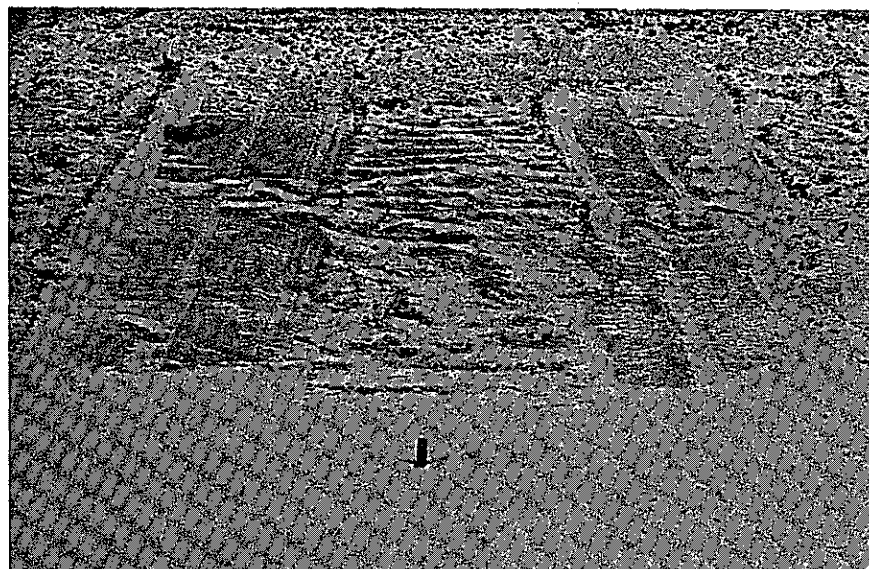
Plate 35 - Soil Seal

The performance of Soil Seal was judged satisfactory because although the surface had been scoured by blowing sand it had not been penetrated.

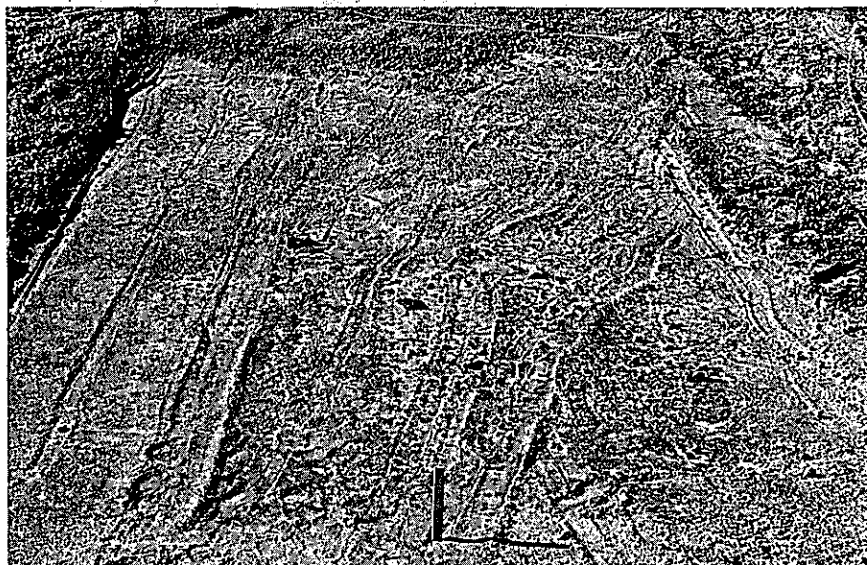
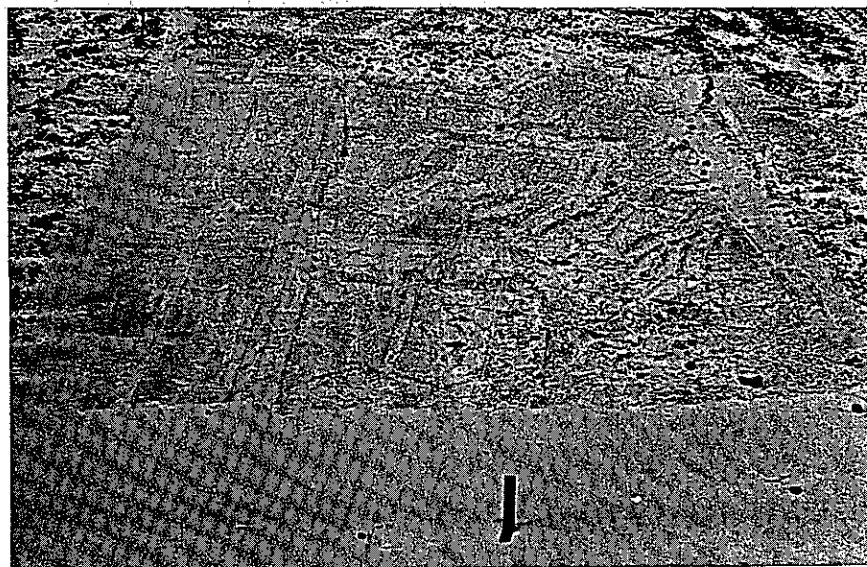
Plate 36 - Soil-Lok

The performance of Soil-Lok was satisfactory and the surface was not damaged at all.

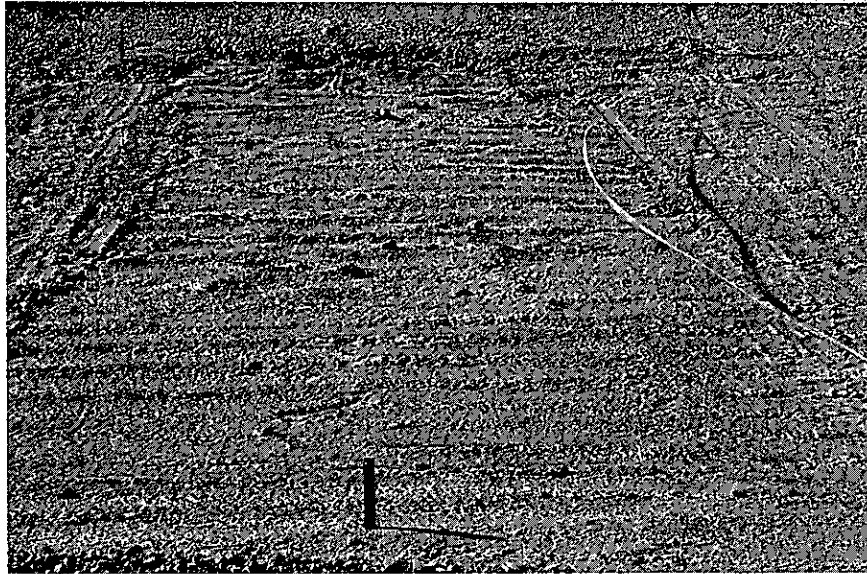
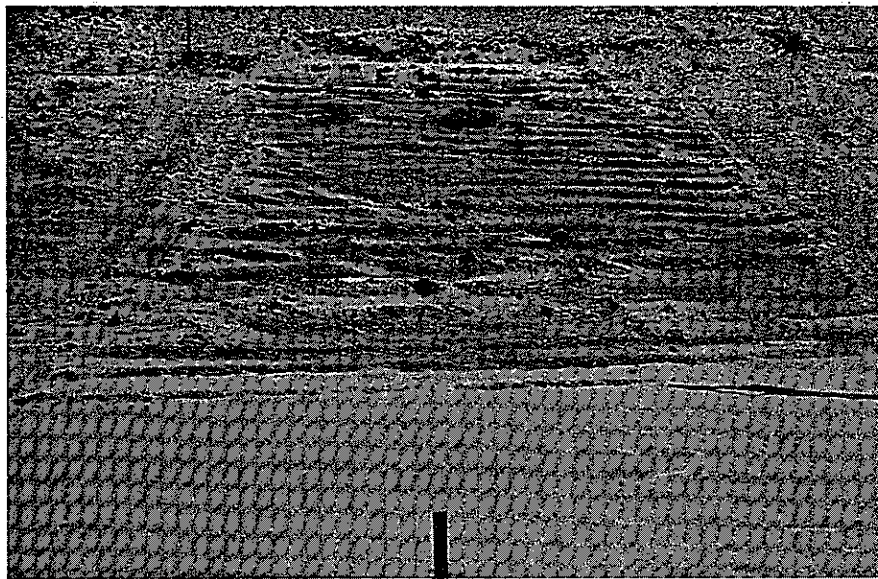
Plate 39 - Surfaseal

The performance of Surfaseal was judged satisfactory because, although scoured by blowing sand, the surface was not penetrated.

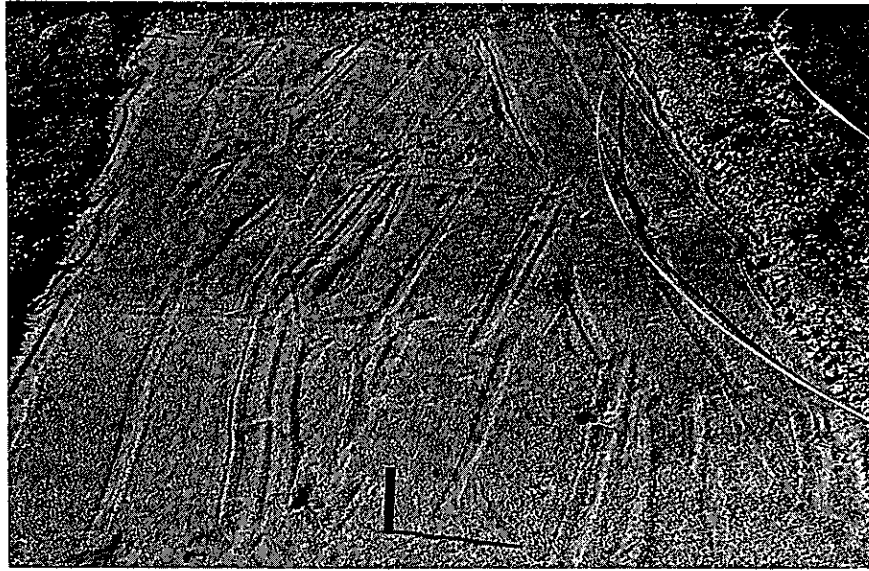
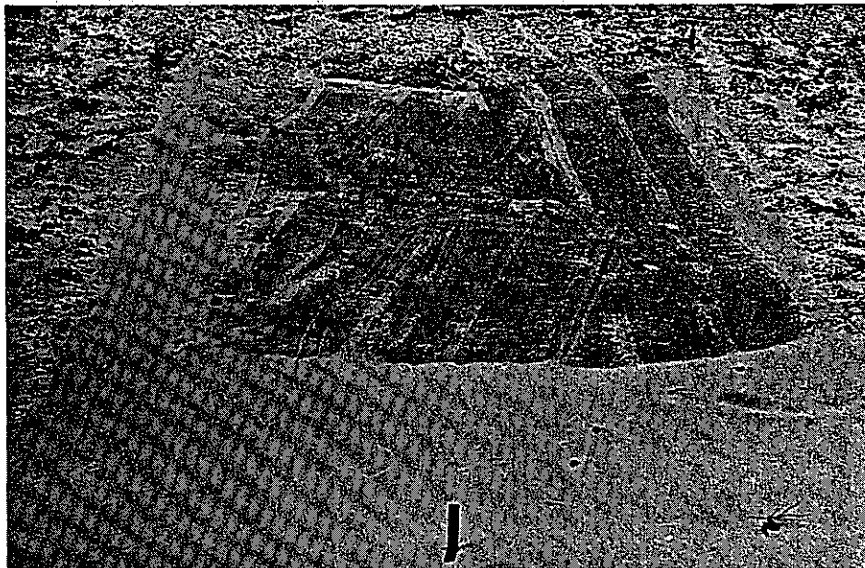
Plate 40 - Terra-Krete

The performance of Terra-Krete was judged satisfactory because the blowing sand which scoured the surface did not penetrate it.

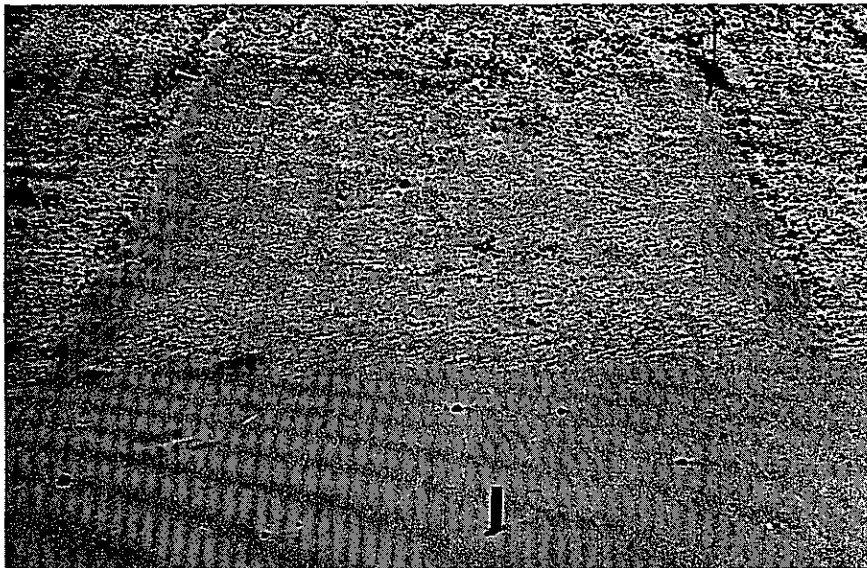
Plate 42 - Verdyol (Super)

The performance of Verdyol (Super) was judged unsatisfactory because the surface was completely destroyed and most fine material on the test plots has blown away.
